ADVANCED METALLIC AIR VEHICLE STRUCTURE PROGRAM

GENERAL DYNAMICS
FORT WORTH DIVISION

JUNE 1975

FOURTH INTERIM REPORT ✓
TECHNICAL REPORT AFFDL-TR-75-40

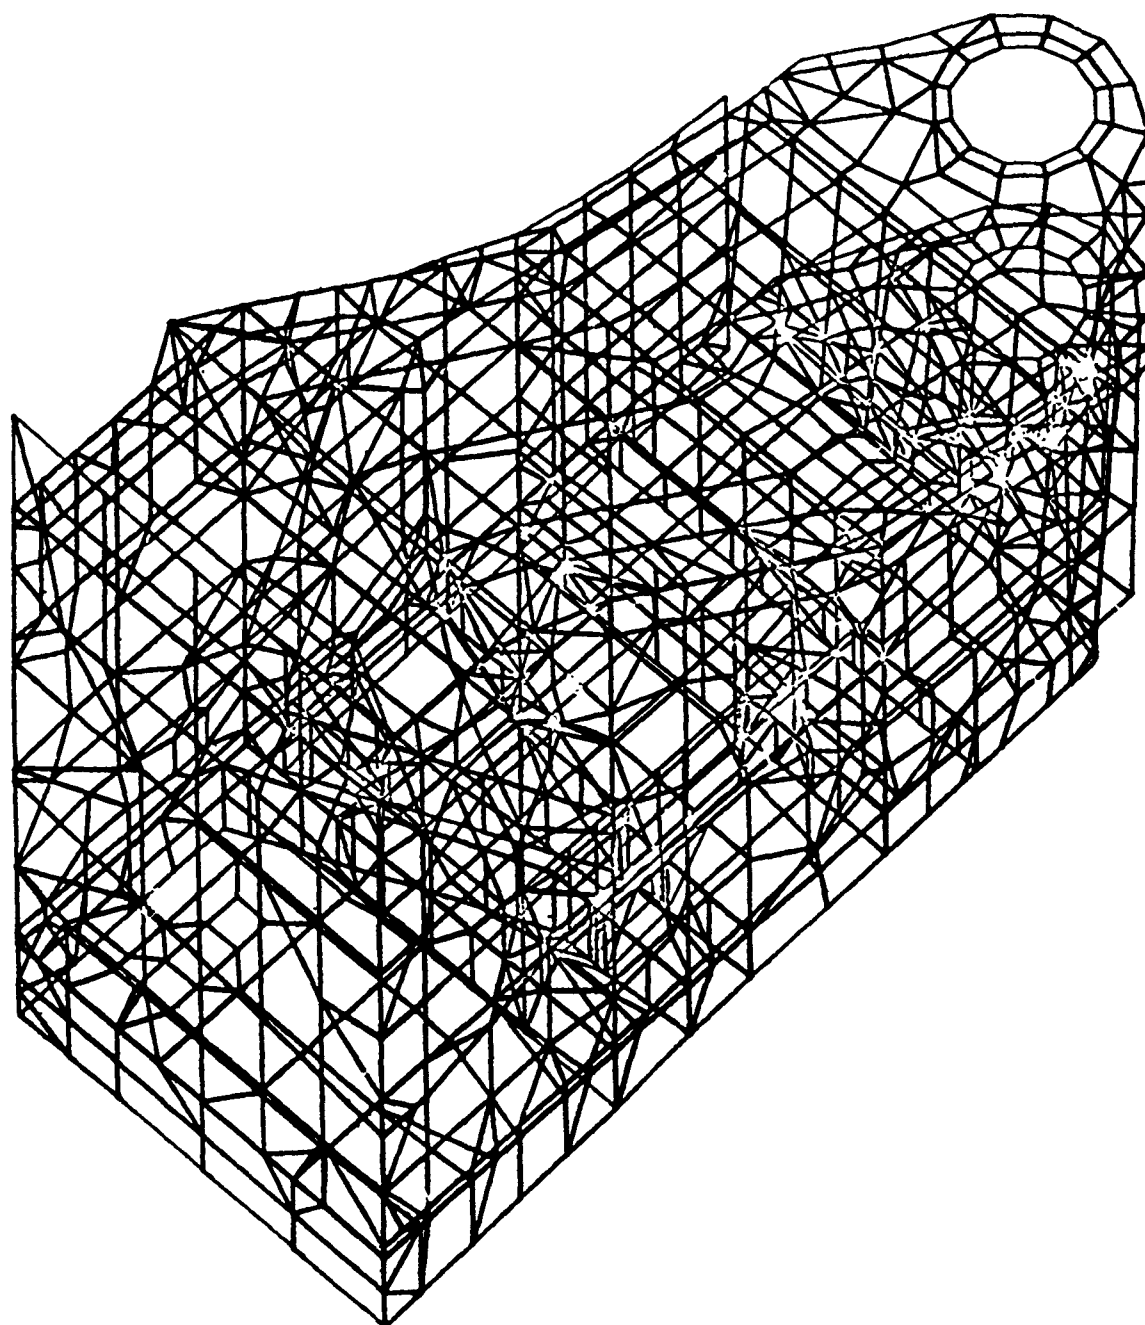
Figure 2.1.2-1 OVERALL MODEL (TN1)-NBB-5 SERIES

The TN1 constant strain element model of the WCTS representative of the current design was run for all of the design conditions. General Dynamics preprocessing procedure UE4 was used to obtain the minimum node separation for optimum computer time usage. Procedure UD6 was used to obtain plots of model geometry for checking purposes. Another program was used to check the input panel point loads for static balance. After the actual solution run, Procedure UD5 was used to obtain final stress and geometry plots.

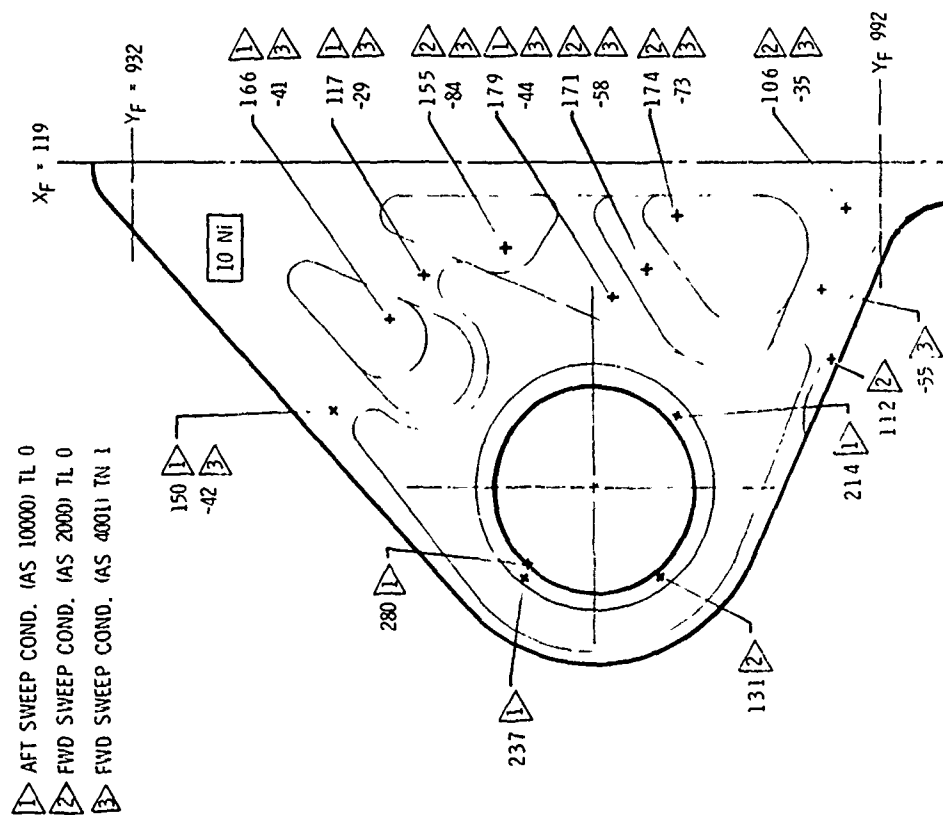
Figure 2.1.2-5 REPRESENTATIVE LOWER LUG ULTIMATE PRINCIPAL STRESS LEVELS - KSI - GROSS SECTION

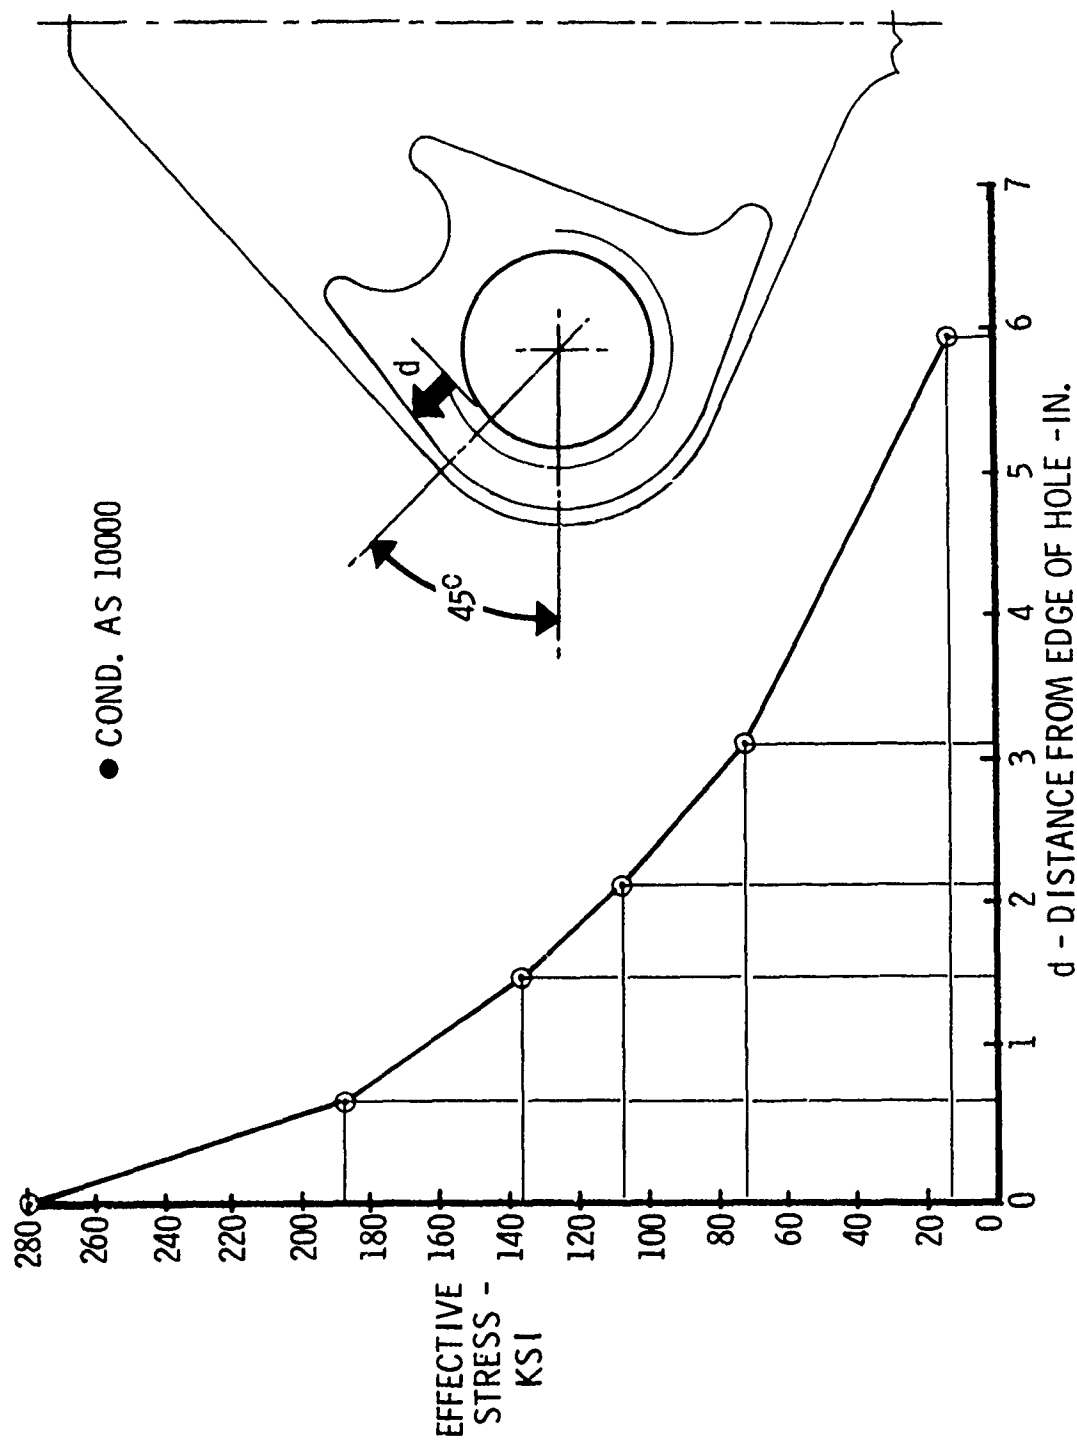
Figure 2.1.2-6 NBB LOWER LUG - TLO MODEL TYPICAL ULTIMATE EFFECTIVE STRESS DISTRIBUTION

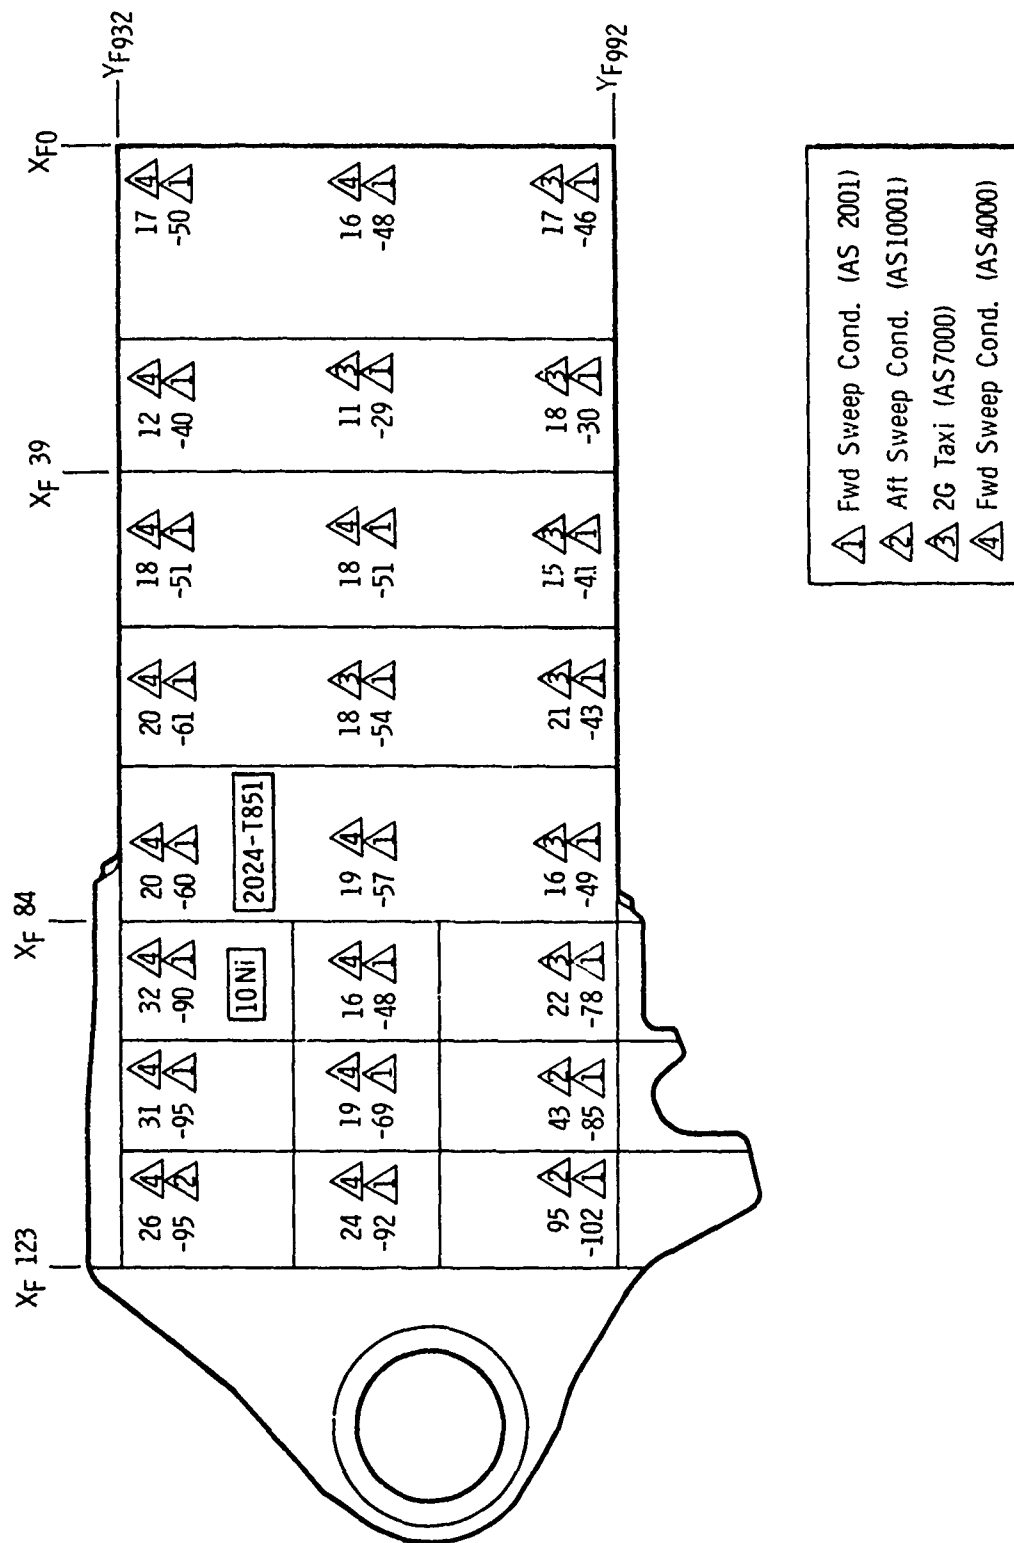
Figure 2.1.2-7 REPRESENTATIVE UPPER COVER ULTIMATE PRINCIPAL STRESS LEVELS - KSI - GROSS SECTION-TN 1 MODEL

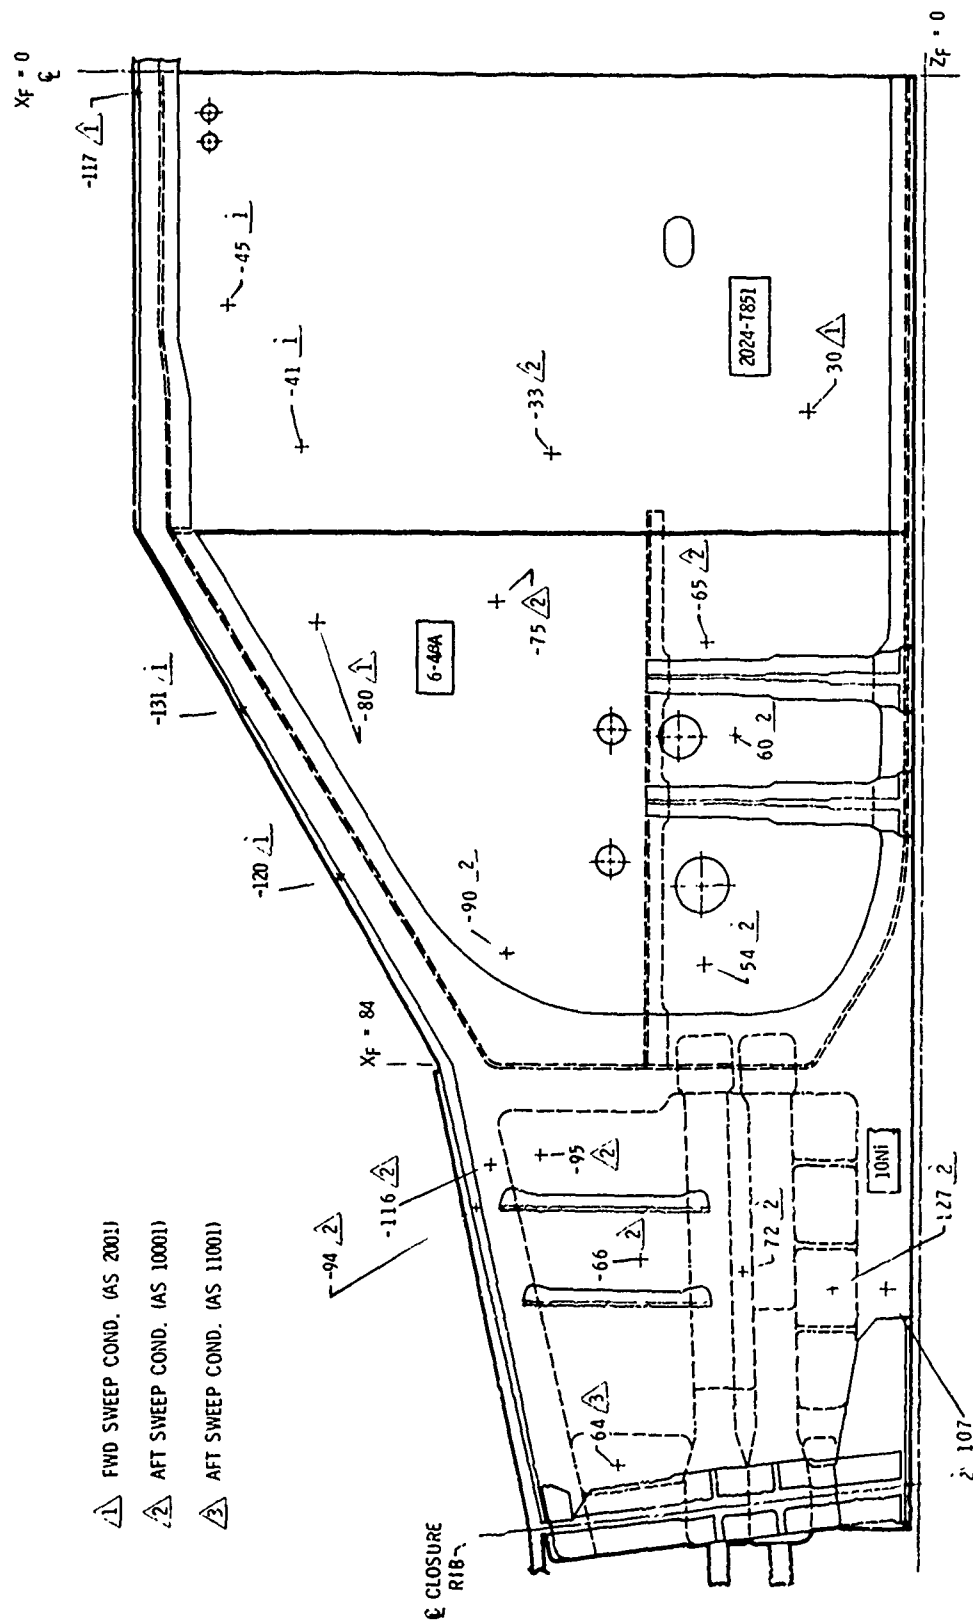
Figure 2.1.2-9 REPRESENTATIVE Y_F 932 BULKHEAD ULTIMATE PRINCIPAL STRESS LEVELS - KSI - GROSS SECTION - TN1 MODEL

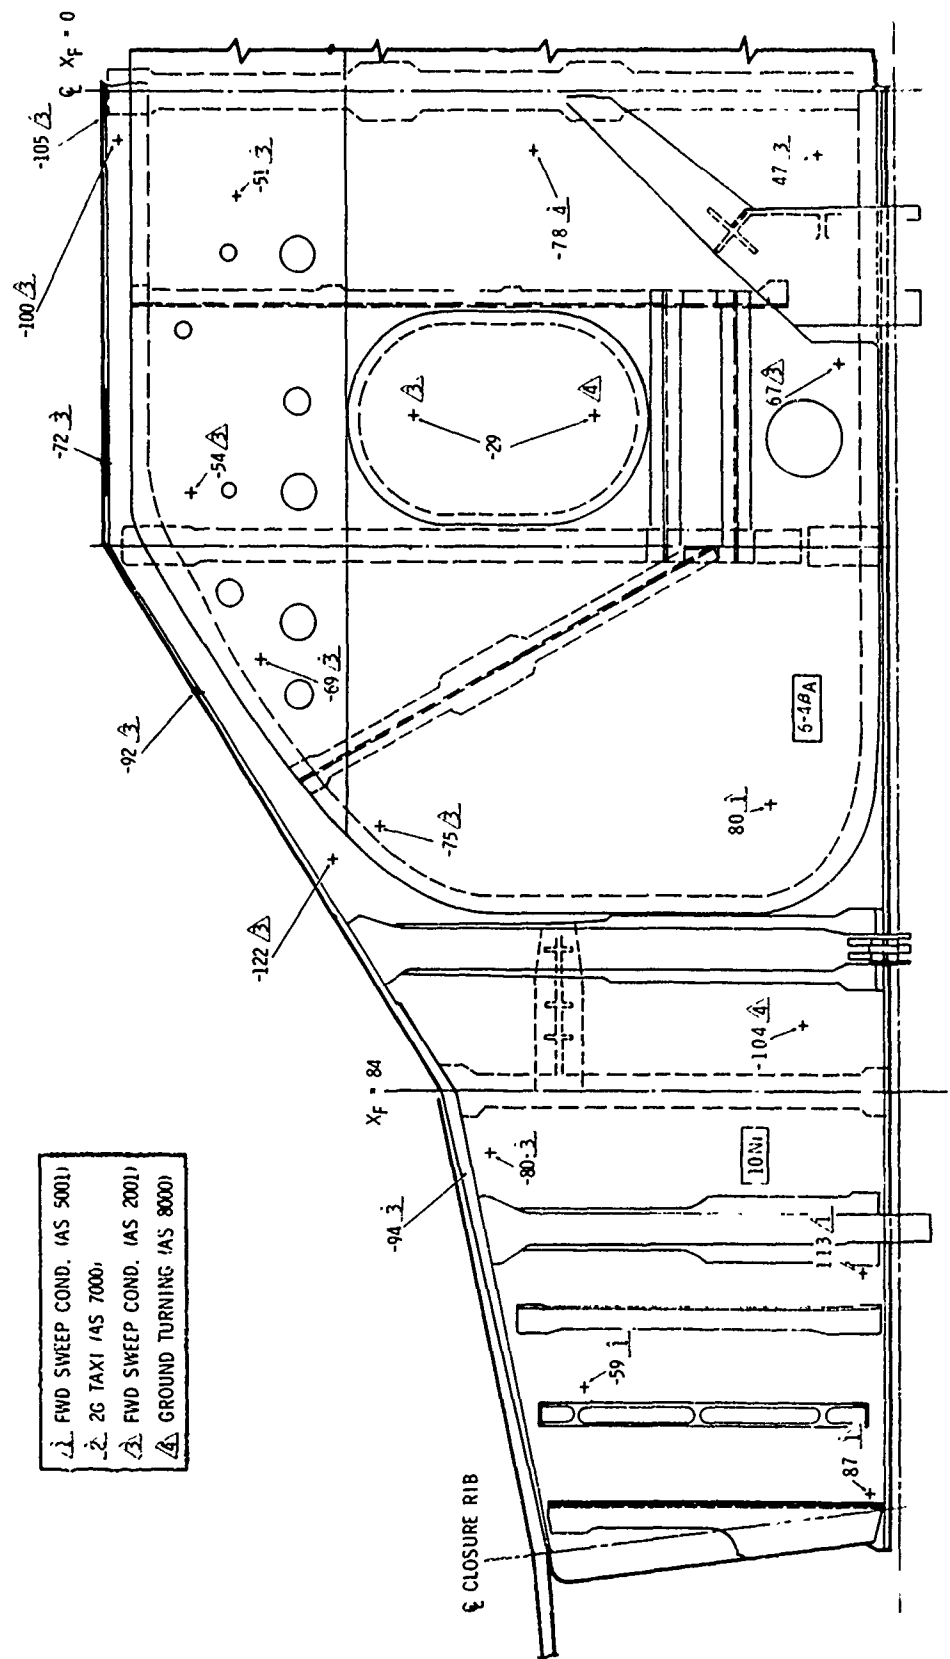
Figure 2.1.2-10 REPRESENTATIVE Y_F 992 BULKHEAD ULTIMATE PRINCIPAL STRESS LEVELS - KSI - CROSS SECTION - TN1 MODEL

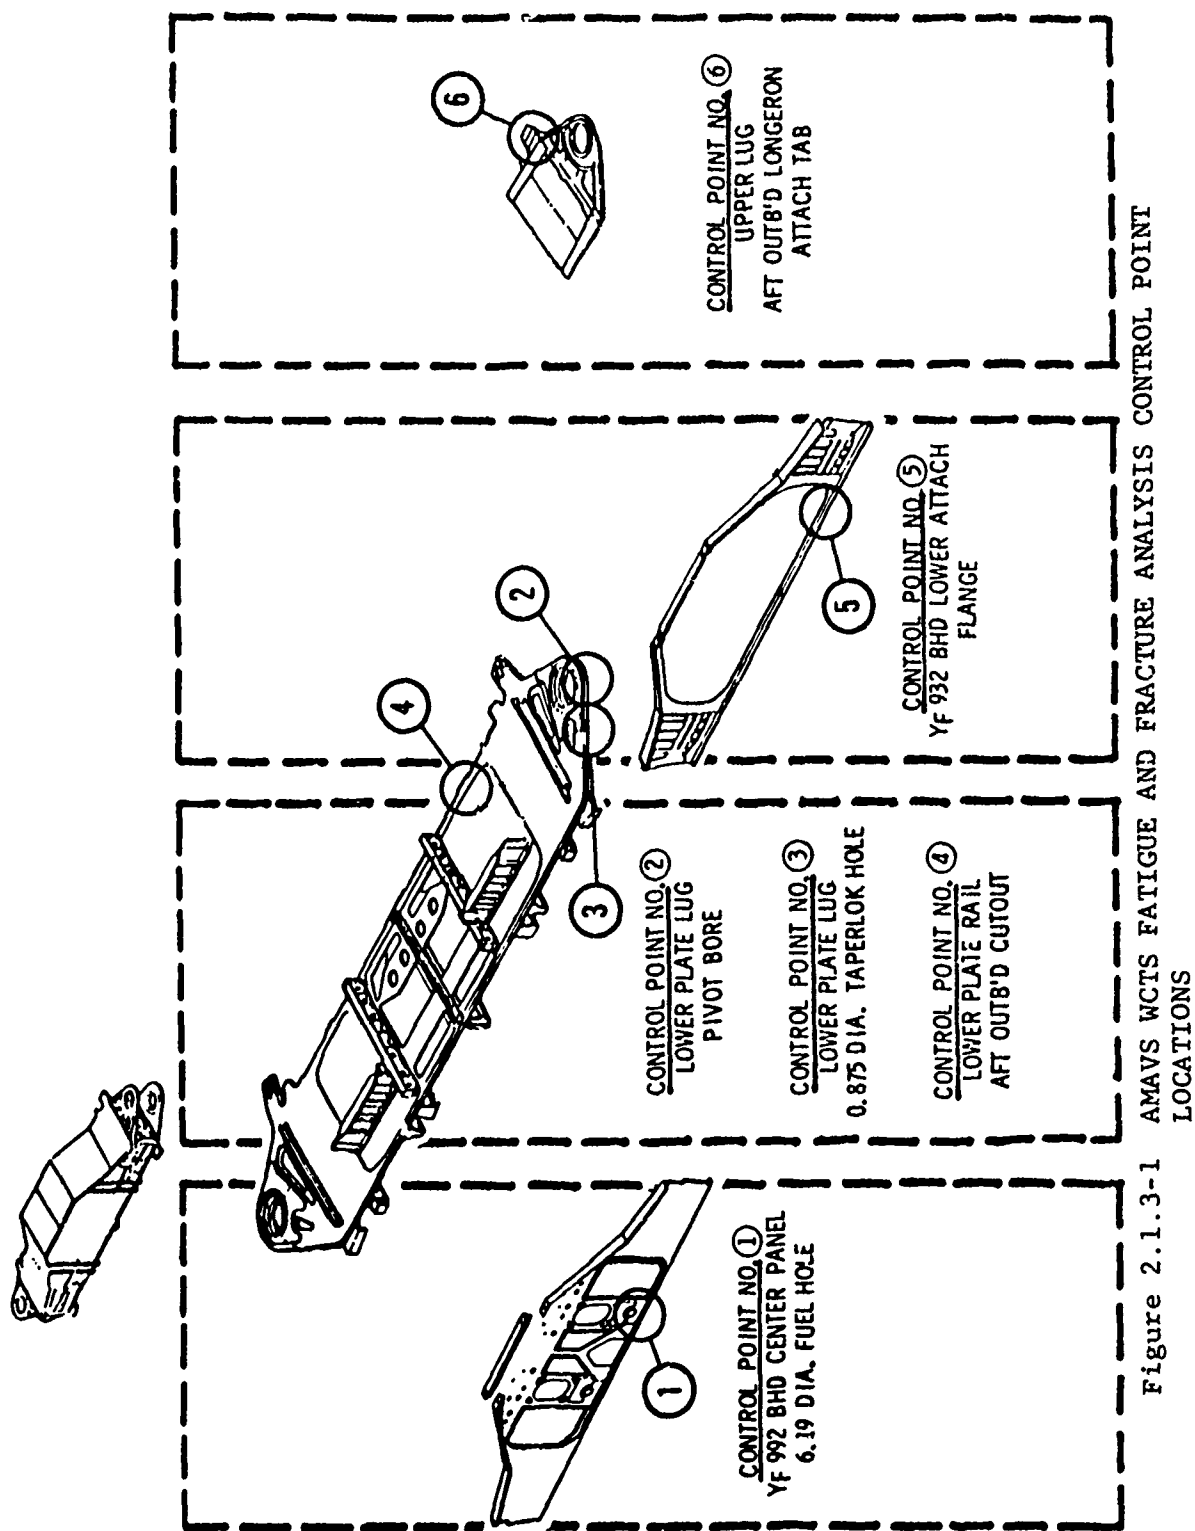
Figure 2.1.3-1 AMAVS WCTS FATIGUE AND FRACTURE ANALYSIS CONTROL POINT LOCATIONS

Crack growth analyses based on linear elastic fracture mechanics were conducted at the six control points (Reference Figure 2.1.3-1) to determine the crack growth characteristics of the WCTS. Analyses were conducted in accordance with the AMAVS fracture control plan (FZM-6068) requirements using the NBB-5-4 math model gross section principal stresses. An initial crack length of 0.15 inches was assumed to exist in the most unfavorable orientation with respect to the applied stresses and material properties.

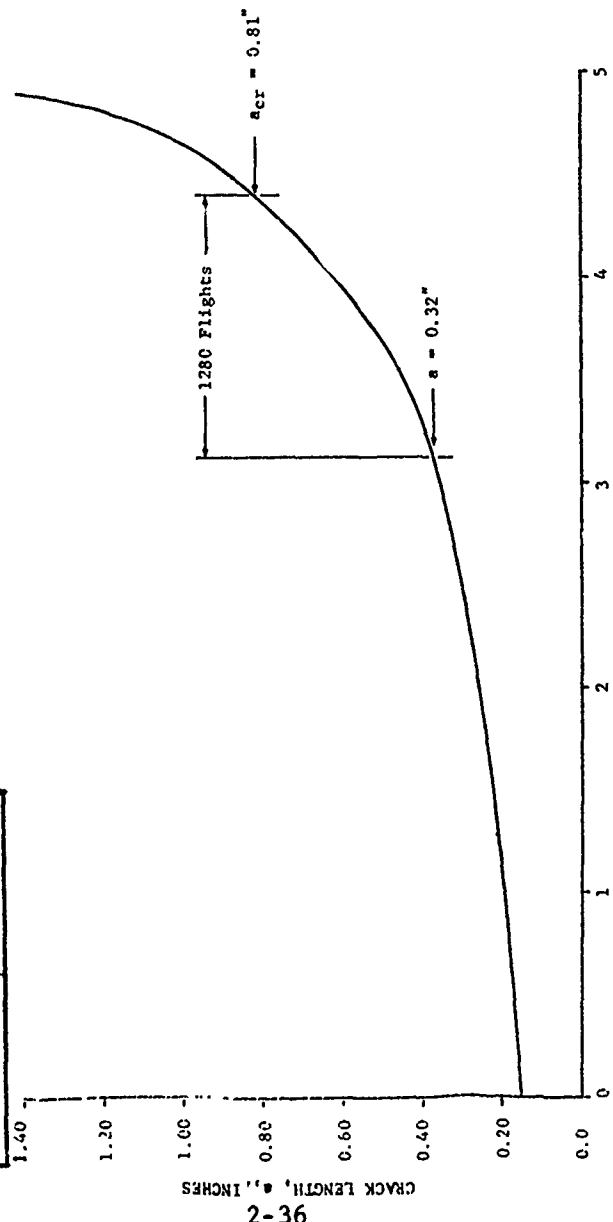
MATERIAL:	6AL-4V TITANIUM
ENVIRONMENT:	SUMP TANK WATER
S_{IC} :	80 KSI $\sqrt{\text{IN.}}$
RETARDATION:	$m = 0$
INITIAL CRACK:	$a_i = 0.15 \text{ INCHES}$

Figure 2.1.3-2 AMAVS WCTS CRACK GROWTH ANALYSIS CONTROL POINT NO. 1
- Y_F 992 BHD FUEL TRANSFER HOLE, X_F 29

Gross section stresses, critical crack length, and type of crack used at each control point are summarized in Table 2.1.3-I. Crack growth rates as a function of the baseline aircraft flights are summarized for the six control points in Figures 2.1.3-2 thru 2.1.3-7.

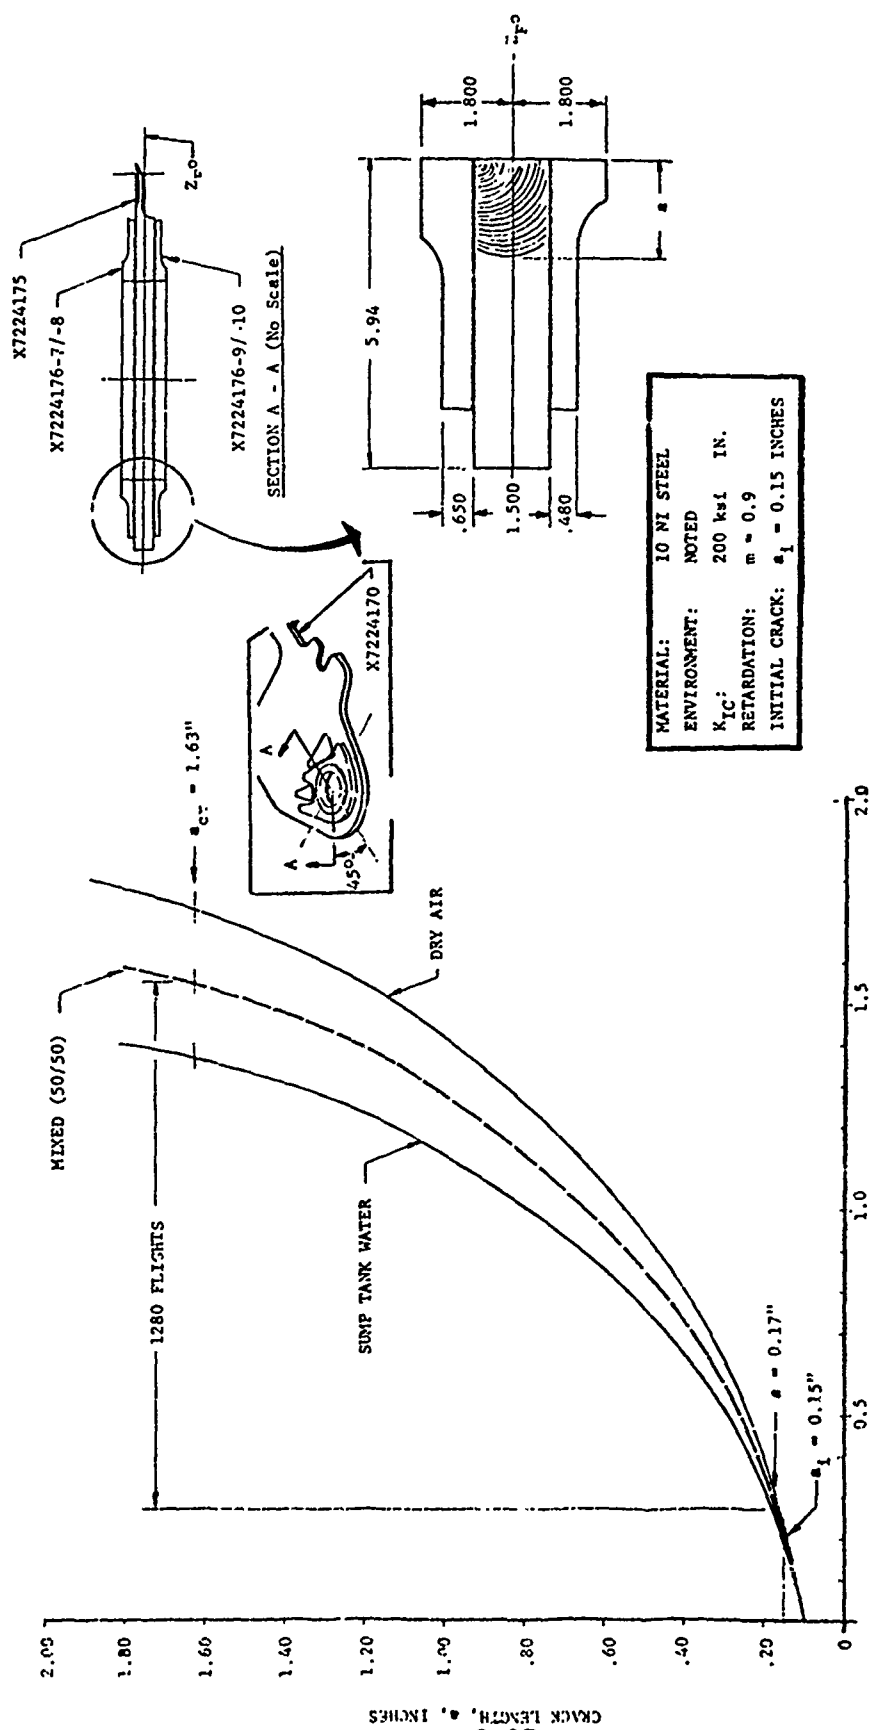
Figure 2.1.3-3 AMAVS WCTS CRACK GROWTH ANALYSIS CONTROL POINT NO. 2
- LOWER PLATE LUG, PIVOT BORE

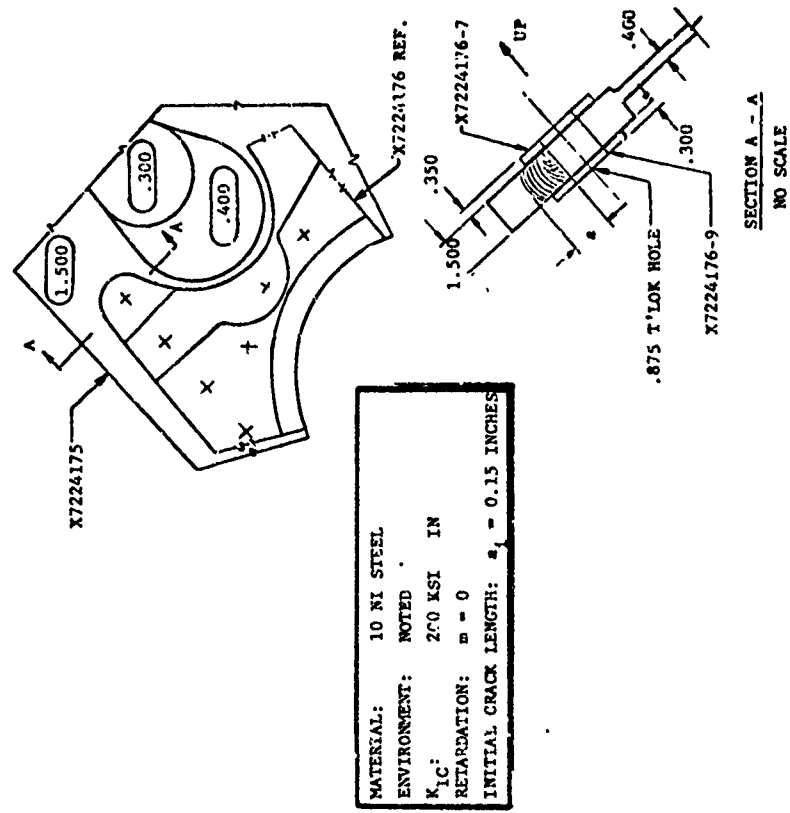
Figure 2.1.3-4 AMAVS WCTS CRACK GROWTH ANALYSIS CONTROL POINT NO. 3
- LOWER PLATE LUG, 0.875 DIA. TAPERLOK HOLE

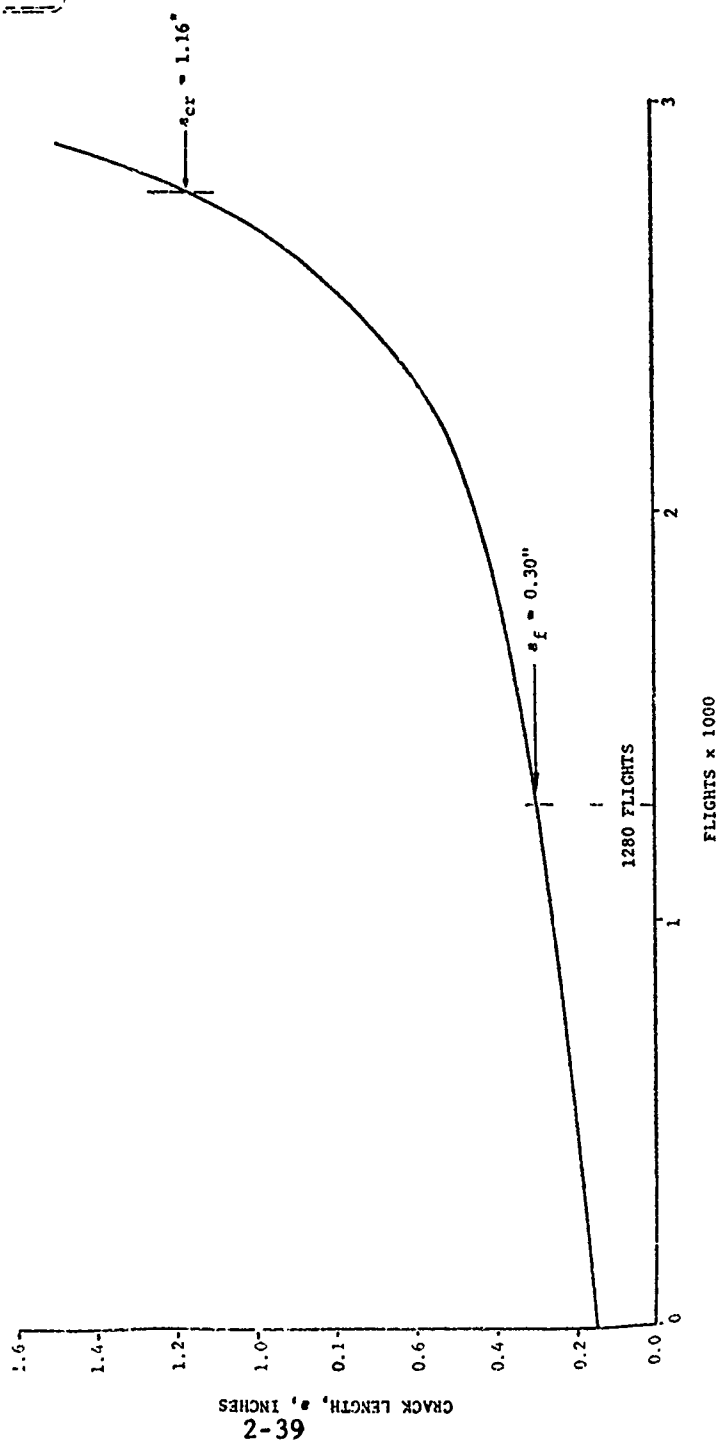
NATERIAL:	10 NI STEEL
ENVIRONMENT:	SUMP TANK WATER
K_{IC} :	200 ksi $\sqrt{\text{in}}$
RETARDATION:	$m = 0.75$
INITIAL CRACK:	$a_i = 0.15$

Figure 2.1.3-5 AMAVS WCTS CRACK GROWTH ANALYSIS CONTROL POINT NO. 4
- LOWER PLATE AFT OUTBOARD

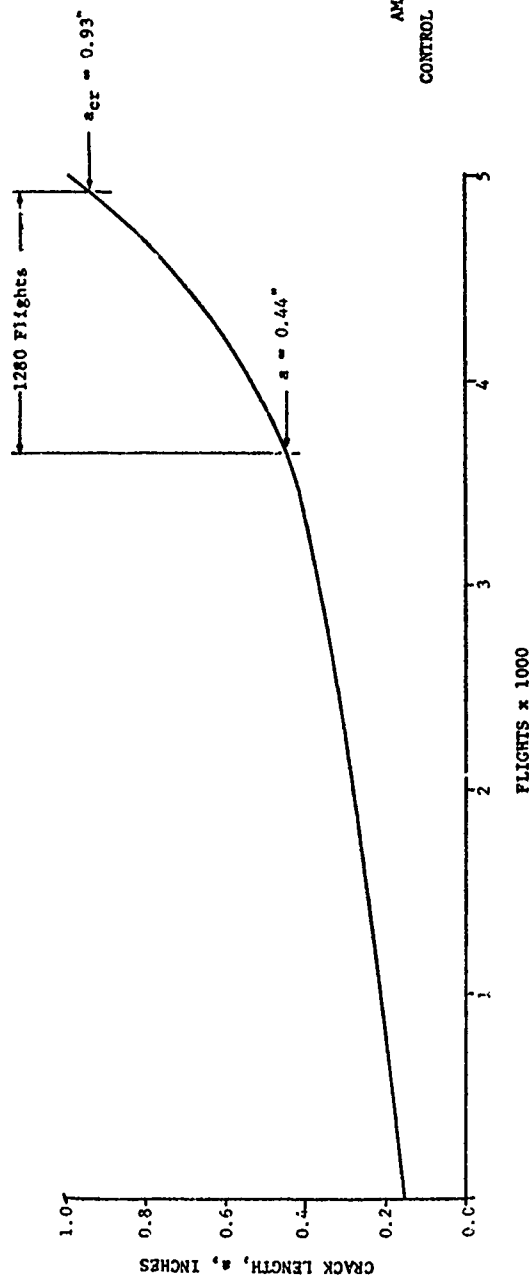
MATERIAL:	10 NI STEEL
ENVIRONMENT:	SIMP TANK WATER
K_{IC} :	200 KSI $\sqrt{\text{IN.}}$
RETARDATION:	$m = 0.75$
INITIAL CRACK:	$a_i = 0.15$ INCHES

Figure 2.1.3-6 AMAVS WCTS CRACK GROWTH ANALYSIS CONTROL POINT NO. 5
- Y_F 932 BHD LOWER FLANGE

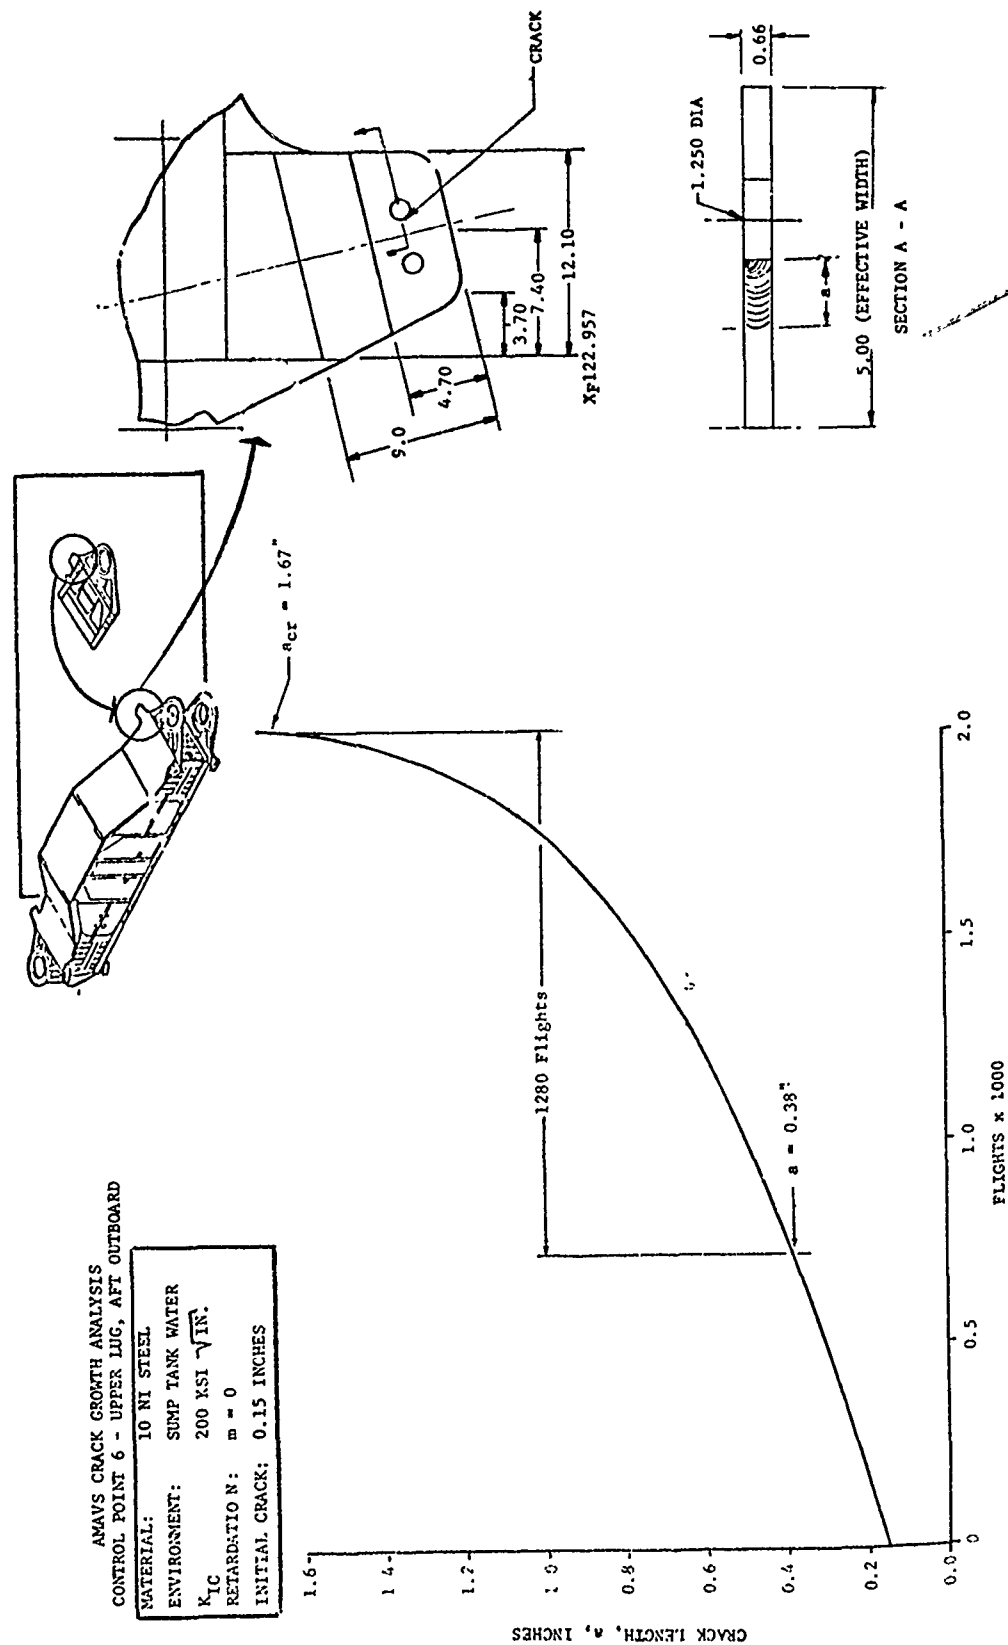
Figure 2.1.3-7 AMAVS WCTS CRACK GROWTH ANALYSIS CONTROL POINT NO. 6
- UPPER LUG, AFT OUTBOARD

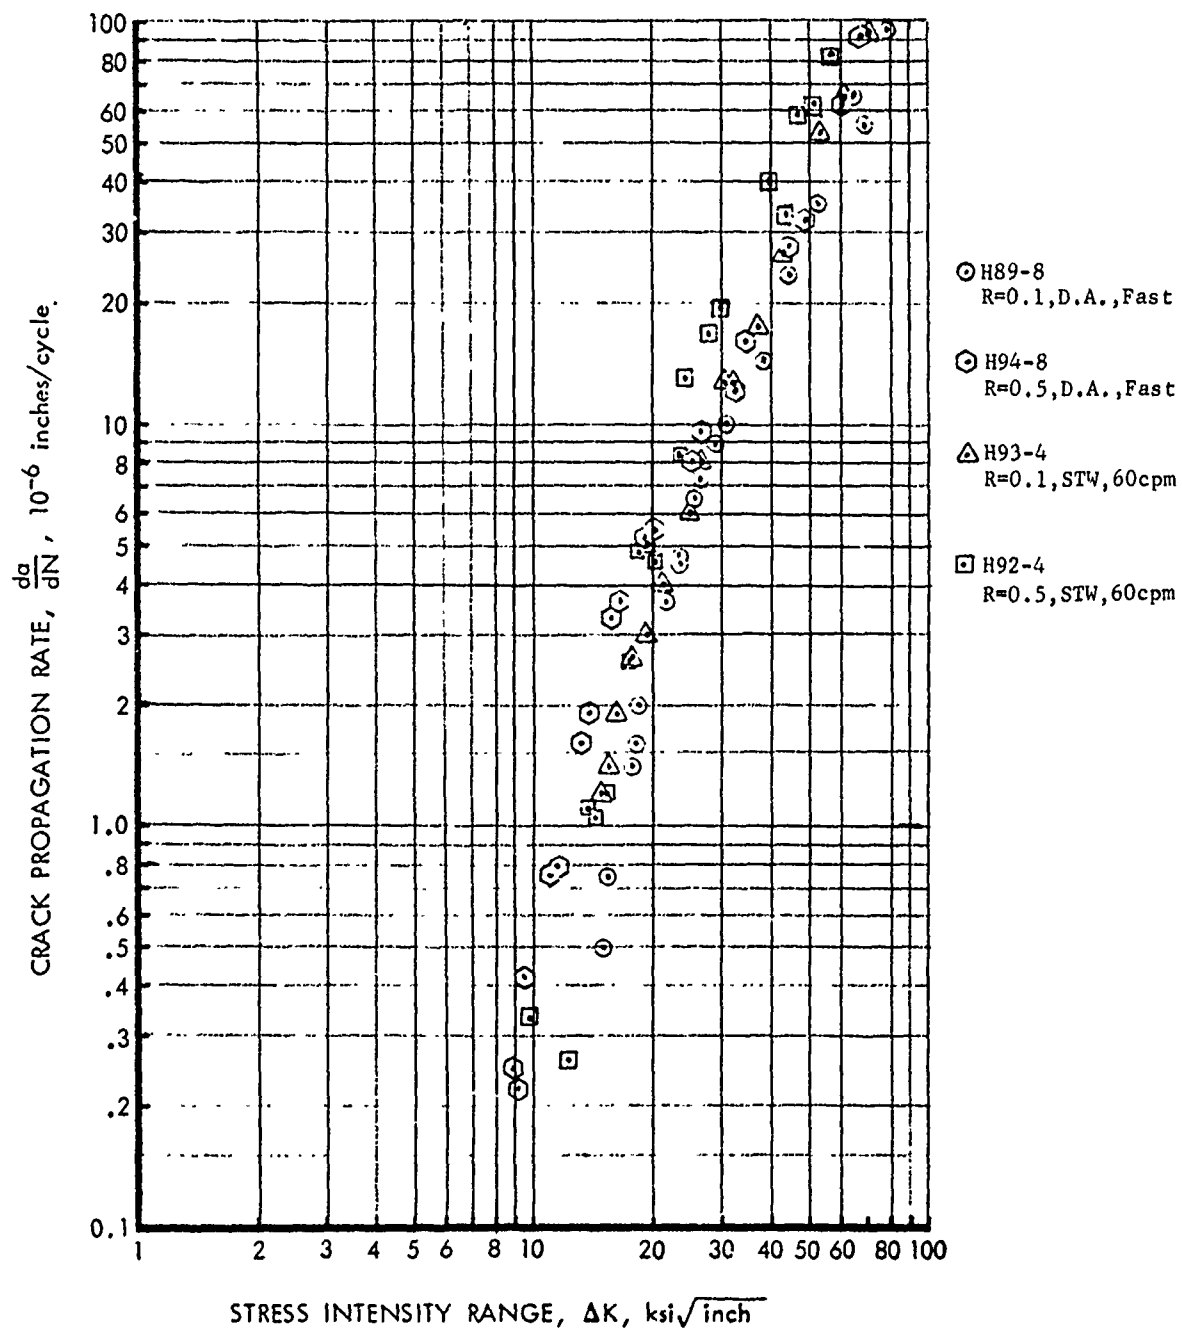
Figure 2.1.4-2 EB-WELDED, 10 NI STEEL ALLOY, CRACKLINE
AT Q_u OF WELD

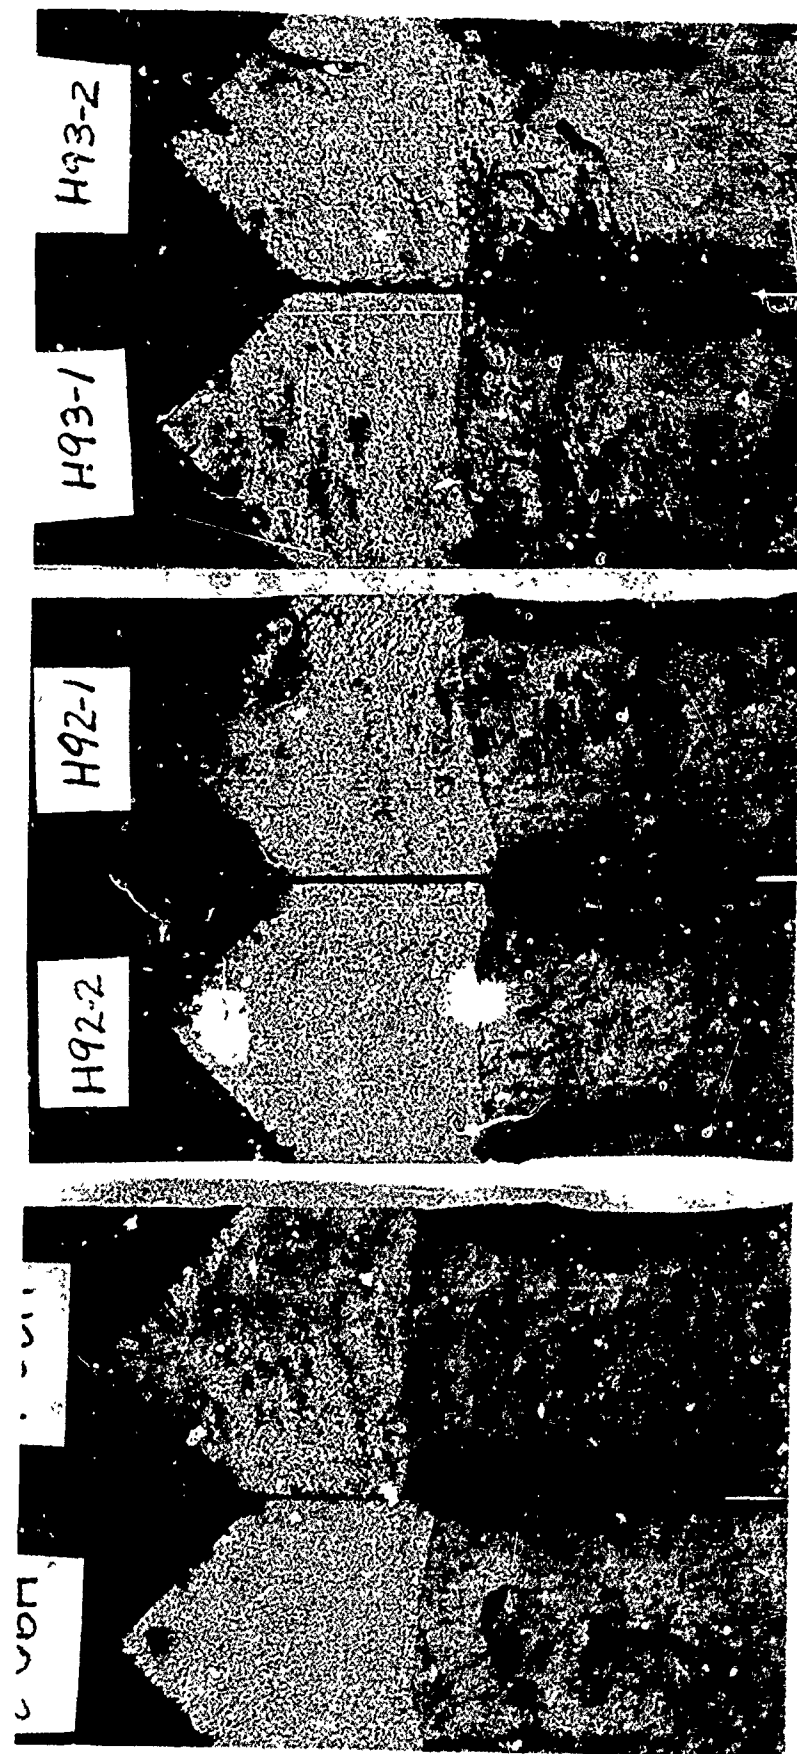
Figure 2.1.4-3 FRACTURE FACE OF FRACTURE TOUGHNESS SPECIMENS

The results of the fracture toughness testing are shown in Table 2.1.4-IV. Photos of the fracture faces of the various specimens are shown in Figure 2.1.4-3. Figure 2.1.4-4 shows a side view of the fracture of specimens H93-1 and H93-2 and shows that the toughness of the weld joint is fairly uniform in all areas of the weld. This photo was taken perpendicular to the crack path and etched to show the weld and HAZ areas.

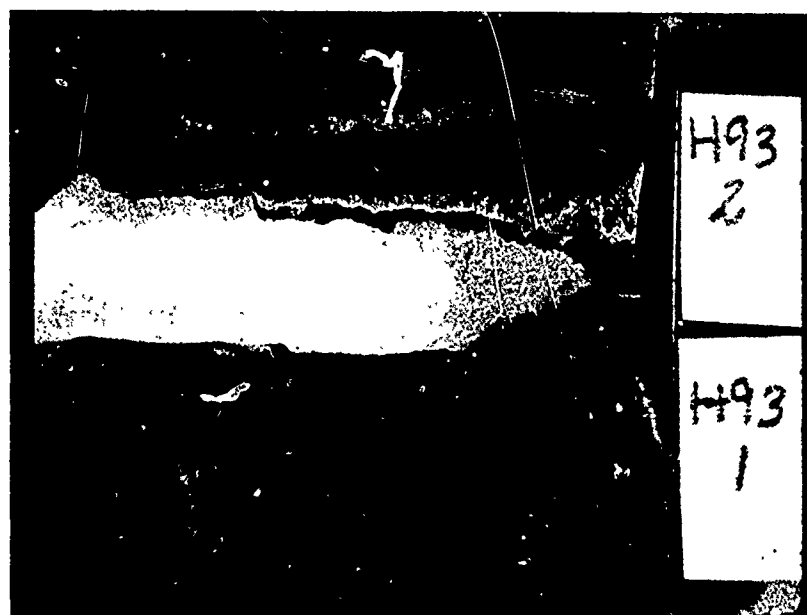
Figure 2.1.4-4 WELD FRACTURE LINE OF FRACTURE TOUGHNESS
SPECIMENS ELECTRON BEAM WELDED (2.5 MAG)

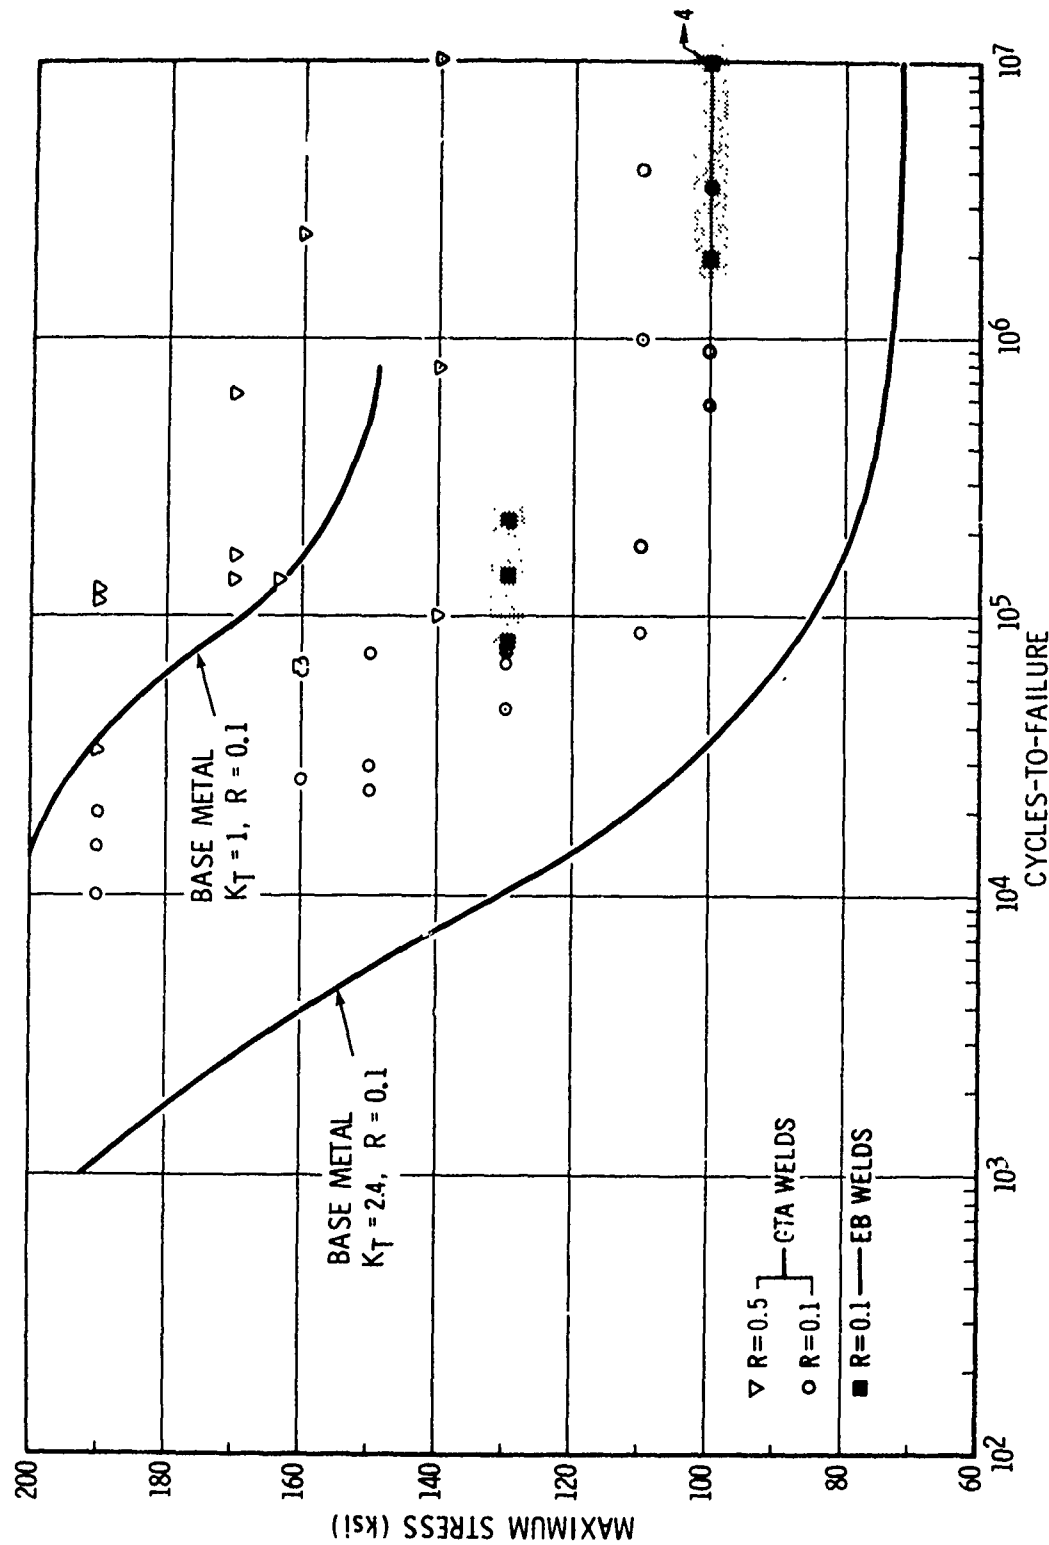
Figure 2.1.4-5 FATIGUE DATA SUMMARY - 10 NICKEL STEEL WELDMENTS
